Seismic Performance of the King Cross Steel Profile in Interior Reinforced Concrete Beam-column Joint

Rahmani Kadarningsih,^{1,2*} Iman Satyarno,¹ Muslikh¹ and Andreas Triwiyono¹

To cite this article: Kadarningsih, R. et al. (2018). Seismic performance of the king cross steel profile in interior reinforced concrete beam-column joint. *J. Phys. Sci.*, 29(Supp. 2), 99–115, <https://doi.org/10.21315/jps2018.29.s2.8>

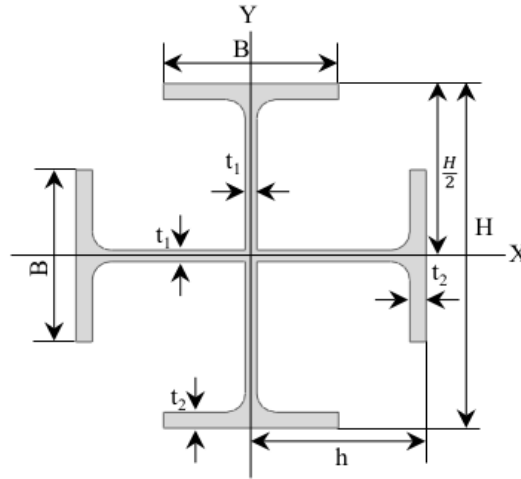
Figure 1: The dimensional details of king cross profile.

where V_{sw} is the shear capacity of web of KCJ (kN), f_{yw} is the yield strength of web (MPa), H is the depth of web (mm), t_l denotes the thick of web (mm), f_{yf} is the yield strength of flange (MPa), B is the depth of flange (mm), t_2 is the thickness of flange (mm), and the dimensional details of king cross profile are presented in Figure 1.

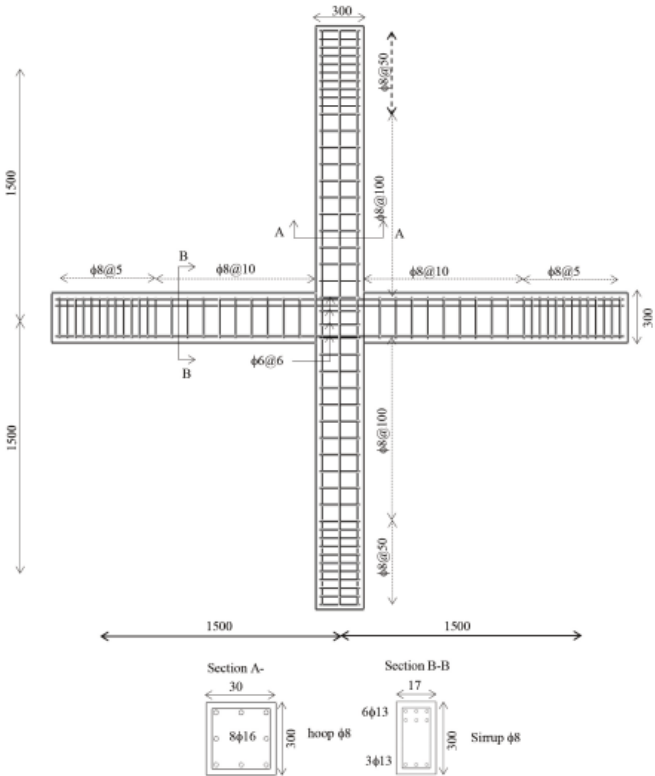
Figure 2: Dimensional details of beam-column joint with SJ.

Beam-column joint subassemblies were designed as beam column specimen with a stirrup reinforcement (SJ) and beam-column specimen with KCJ in the joint, respectively. The descriptions of the specimens are presented in Table 3 and the dimensional details of test specimen are presented in Figures 2 and 3.

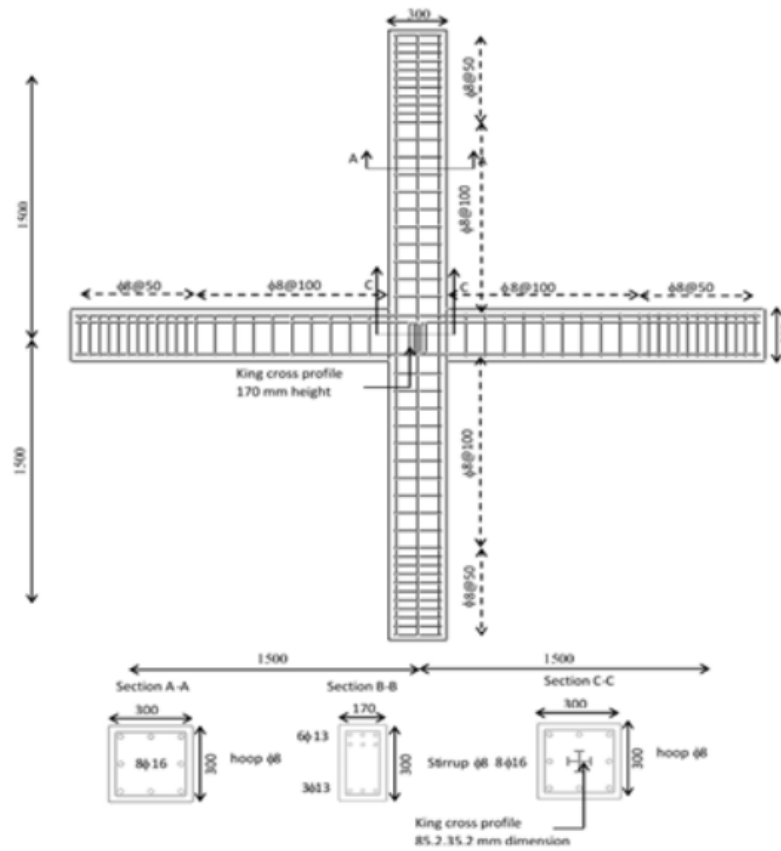
Figure 3: Dimensional details of beam-column joint with king cross profile.

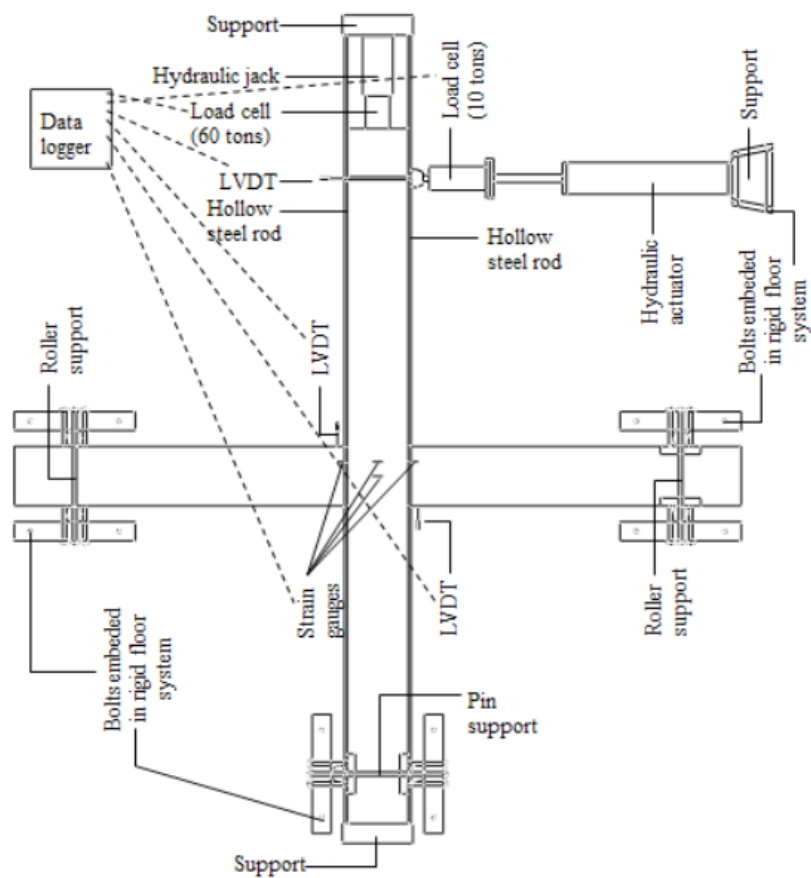
The schematic representation of the test set up is shown in Figure 4, similar to report by Wijaya.¹² The specimens were placed in horizontal position on the surface of the rigid floor. The axial load was imposed at the end of the column above by using a hydraulic jack. The axial load magnitude was constantly kept at 180 kN during the test. It was less than $\alpha f'_c A_g$, where f'_c is concrete compressive strength of 35 MPa, A_g refers to the gross area of the column (90000 mm²) and $\alpha = 0.1$ because the concrete shear capacity of joint has been calculated using Equation 2, not using the equation based on SK SNI-T-15-1991-03 as follows.⁶

Figure 4: Schematic arrangement of cyclic test set up.¹²

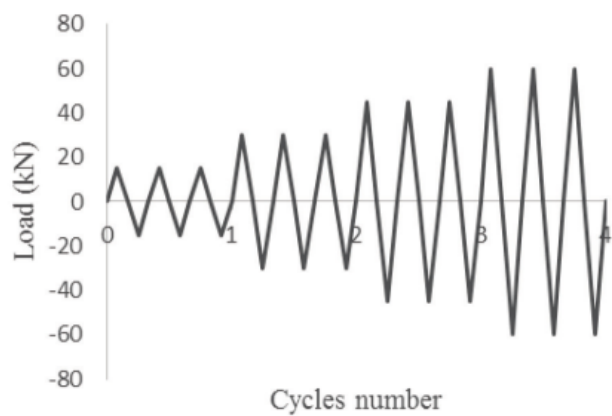
Figure 5: Load sequence diagram.

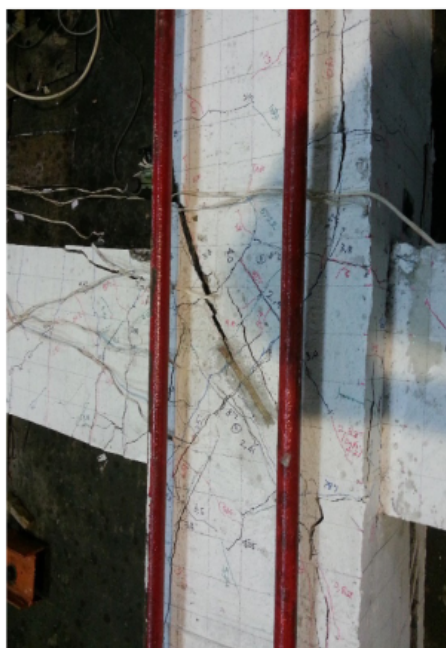
The typical crack pattern of control specimens SJ and KCJ was presented in Figures 6 and 7. In control specimens, the first visible crack appeared at the joint. Beam-column joint remained undamaged at low displacement level. With the increase in displacement level, diagonal tension crack appeared at the joint panel. This was followed by the crack formation in beam close to column interface with the increase in displacement. The failure mechanism was a mixing mechanism in which diagonal cracking in the joint panel was accompanied by a flexural damage in the beam. The yielding of stirrup reinforcement in joint occurred before yielding of steel reinforcement bar in the beam.

Figure 6: Crack pattern in control specimen SJ.

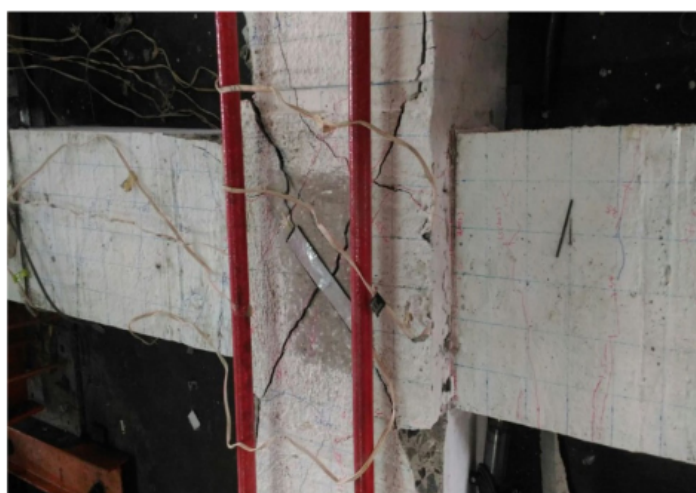
Figure 7: Crack pattern in specimens with KCJ.

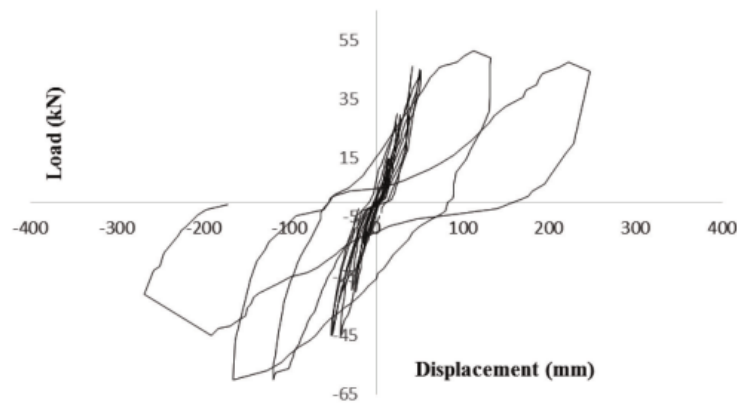
Load-displacement hysteretic curves of both specimen tests are presented in Figures 8 and 9. From the shape of the hysteretic loop, it could be observed that SJ and KCJ

had pinching. The pinching illustrates that the mechanism of plastification of both specimens is unstable. Specimens SJ and KCJ suffered from the shear damage in the joint panel, hence no energy was dissipated. This has caused the form of hysteretic loops on both specimens to be pinched. On non-pinched specimens, the plastification mechanism is more stable. The mechanism of plastification on non-pinched specimen occurs by forming a plastic hinge and bending failure on the beam.¹³

Figure 8: Hysteretic curve for SJ.

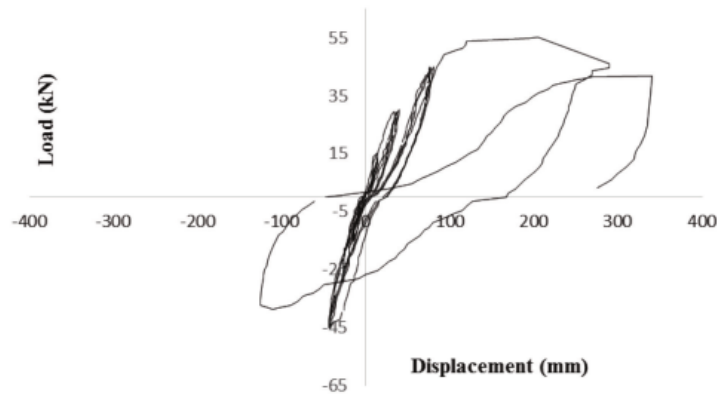
Figure 9: Hysteretic curve for KCJ.

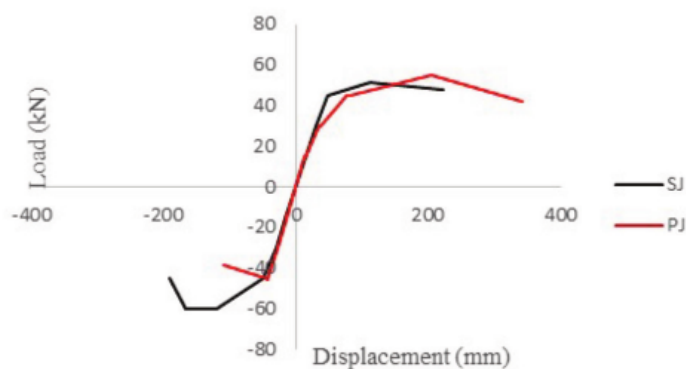
To obtain the peak loads of the test specimen, the envelop curve was drawn by connecting the peak loads at each displacement level in both positive and negative direction. Typical failure envelope of the specimen is presented in Figure 10. Peak load of all the specimens is presented in Table 3. It was observed that the peak load of SJ was higher than that of KCJ. However, the failure of the specimen on the loop hysterical curve could not be excellently represented, especially on the negative load. This occurs because the use of cyclic loading stage (Figure 5) did not conform to FEMA 461/2007 on the conceptual approaches for the development of force controlled loading history.

Figure 10: Failure envelope SJ and PJ.

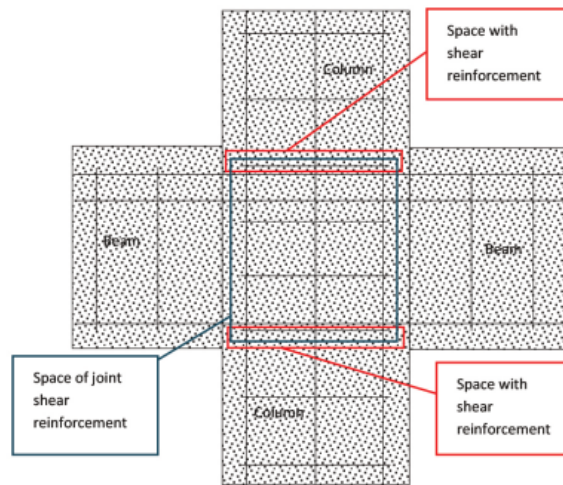
Figure 11: Space of joint shear reinforcement of SJ

The peak load of SJ specimen was higher than KCJ. This condition was caused by several factors. Firstly, as presented in Figures 11 and 12, the king cross steel only resisted the shear in the joint space between the top and the bottom of the longitudinal bar while the space above was left without any reinforcement or being empty. This was different from the SJ specimen. Secondly, the section of king cross steel used was so small so that it was not sufficient to fill the entire section. For this, the section of king cross should be enlarged.

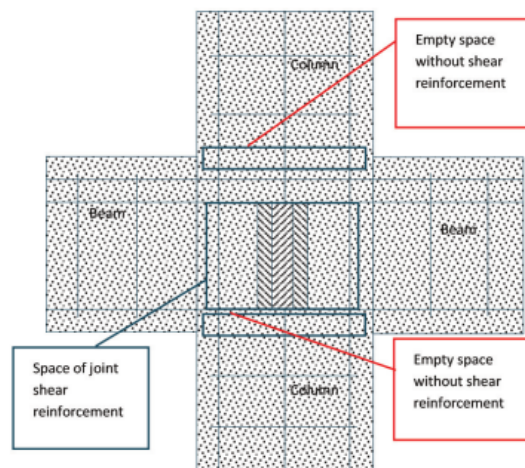
Figure 12: Space of joint shear reinforcement of KCJ.

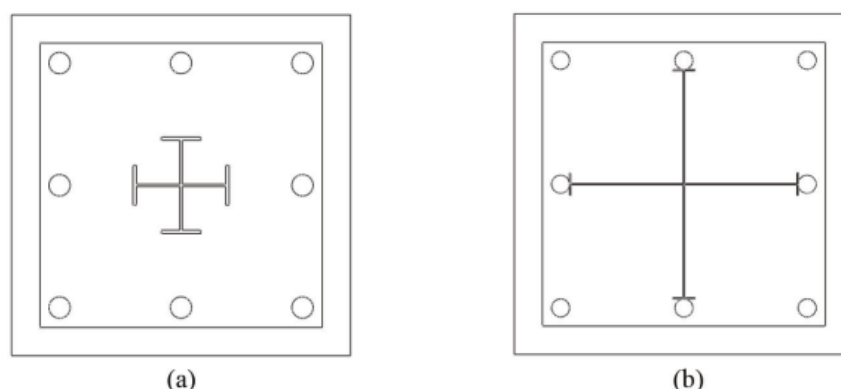
The second reason the peak load of SJ specimen was higher than KCJ was that the section of king cross steel profile used was too small, hence it is not sufficient to fill the entire section, as shown in Figure 13(a). Thus, the section of king cross was enlarged and fixed as shown in Figure 13(b).

Figure 13: Illustrations of (a) the sufficient of king cross profile, and (b) the enlarged of king cross profile with the same of nominal area.
