Píoposed New Jouínal Eíosion Hazaíd Analysis in l'he Limboto Lake Catchment Aíea, Goíontalo Píovince, Indonesia

March 05, 2020

EROSION HAZARD ANALYSIS IN THE LIMBOTO LAKE CATCHEMENT AREA, GORONTALO PROVINCE, INDONESIA

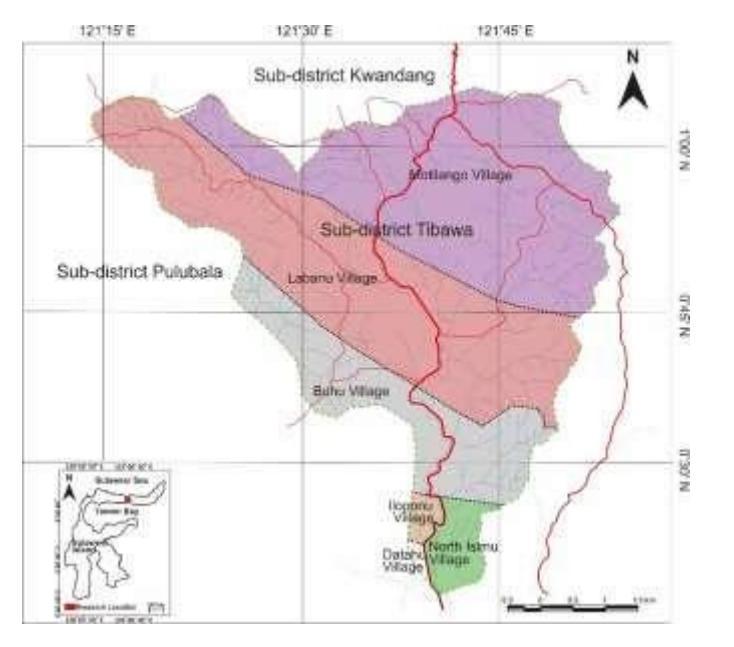
Figure 1. Map of Alo drainage basin

drainage basin covers six villages, namely Datahu, Iloponu, Buhu, Isimu Utara, Labanu, and Motilango village, all under the administration of Tibawa District. This is shown in Figure 1 as follows:

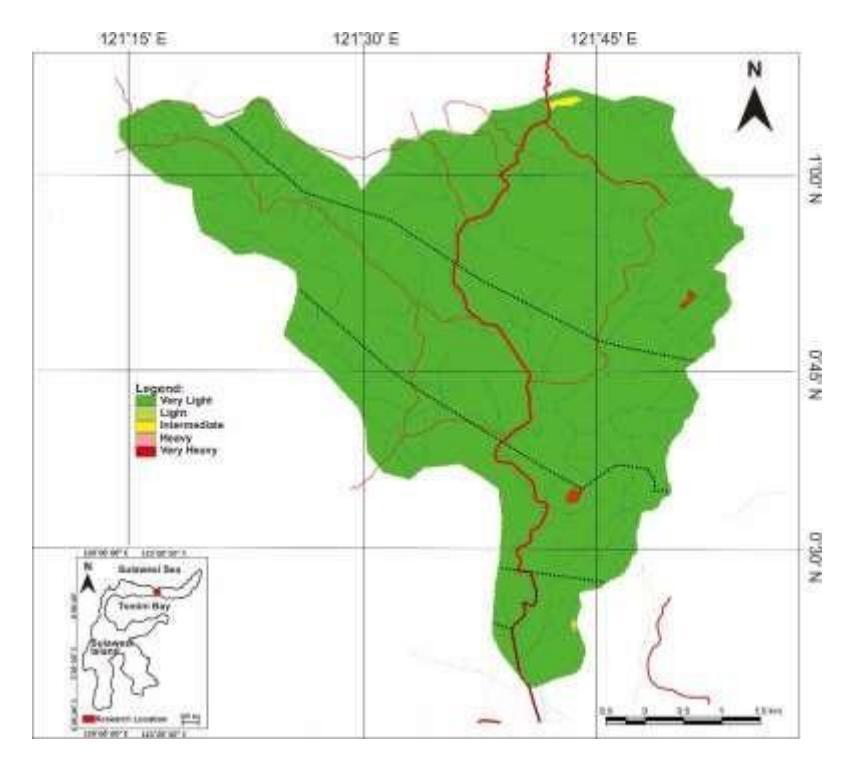
Figure 2. Map of soil surface erosion (A) of Alo watershed

Group III has 20 remaining land units, i.e., D2IB (0.140 ton/ha/year), D1IIIB (1.221 ton/ha/year), D1IIIPc (2.109 ton/ha/year), D1IIPc (0.069 ton/ha/year), D1IIPt (3.341 ton/ha/year), D2IPc (0.022 ton/ha/year), D2IPt (0.069 ton/ha/year), D1IVB (0.154 ton/ha/year), D1IVPc (0.640 ton/ha/year), D1IVPt (3.253 ton/ha/year), D2IB (0.140 ton/ha/year), D1IIIB (1.221 ton/ha/year), D1IIPc (2.109 ton/ha/year), D1IIPc (0.069 ton/ha/year), D1IIPc (0.059 ton/ha/year), D1IVPt (3.253 ton/ha/year), D1IVPt (3.253 ton/ha/year), D1IVPt (0.154 ton/ha/year), D1IVPc (0.640 ton/ha/year), and D1IVPt (3.253 ton/ha/year). Erosion rate of these units is quite small attributable to area of each unit, ergo, the average of soil loss in Alo watershed is classified as small with the loss of 3,1 mm soil annually.

Additionally, all land units of karst hills have a value below 10 ton/hectare/year, those are: K2IB (0.720 ton/ha/year), K1IIIB (0.307 ton/ha/year), K1IIIPc (0.197 ton/ha/year), K2IPk (0.819 ton/ha/year), K2IPm (0.788 ton/ha/year), K1IVB (0.165 ton/ha/year), and K1IVPc (2.287 ton/ha/year). The erosion rate is low, owing to low rate of rain erosivity.

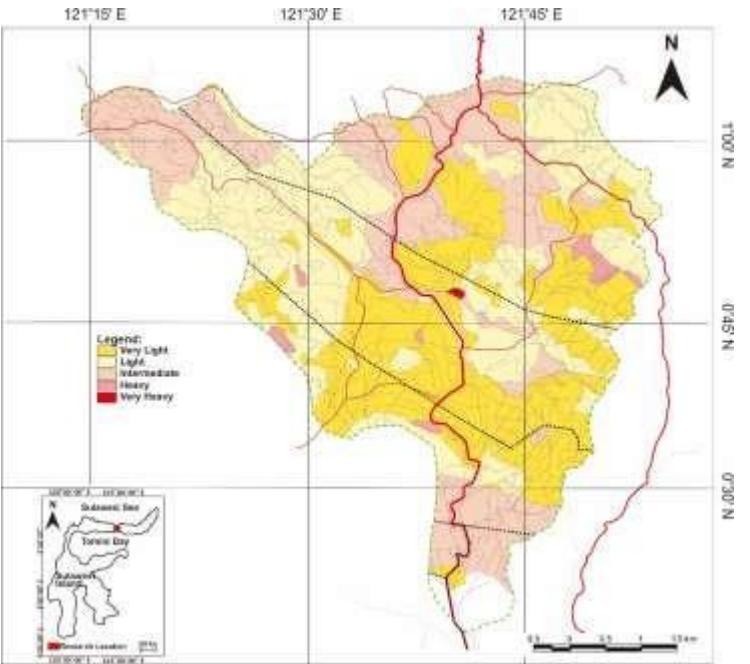
Figure 3. Map of Erosion Hazard Rate in Alo drainage basin

The table shows that four land units, D1IIIPt (89.599 ton/ha/year), D1VPc (15.657 ton/ha/year), S1IVB (67.652 ton/ha/year), and S1IVPt (102.608 ton/ha/year) are in the critical zone. These units are scoring high to extremely high EHR value. This results from the slope steepness and CP value as the key factors. In particular, land unit D1IVPt is in class IV steepness. However, its use as dry farmland makes it under bad caretaking and accordingly has CP value of 0,007. Besides, soil solum of the unit is shallow, only 35 cm, by that, the actual erosion exceeds tolerable erosion rate. Further, Figure 3 displays spread map of EHR in Alo drainage basin.

It shows that 98.75 percents of land units (a total of 6,874.21 hectares) in Alo watershed are in classified as extremely low to moderate. The remaining 1.25 percents are in high – extremely high rate. The maximum erosion hazard rate of Alo basin takes place in some land units. The units involved are D1IVPc (16.88 hectares) in Buhu Village, unit D1IVPc (7.71 hectares) in Labanu Village, two units; S1IVPc and S1IVB in Motilango Village (having

area of 6.83 and 47.11 hectares respectively), and one unit in downstream of Alo basin, S1IVPt, with an area of 5.4 hectares. In total, land units categorized in extremely low hazard rate have accumulated area of 2.200,53 ha, those in the low category have a total of 2,776.64 ha, unit in the moderate class have 1,896.99 hectares, units in high and extremely high have a total area of 93.86 and 5.50 hectares in order. The analysis of erosion hazard spread points out that inappropriate land use in Alo watershed has brought the land capacity to the limit, if not taken care of, it will eventually increase the hazard rate.

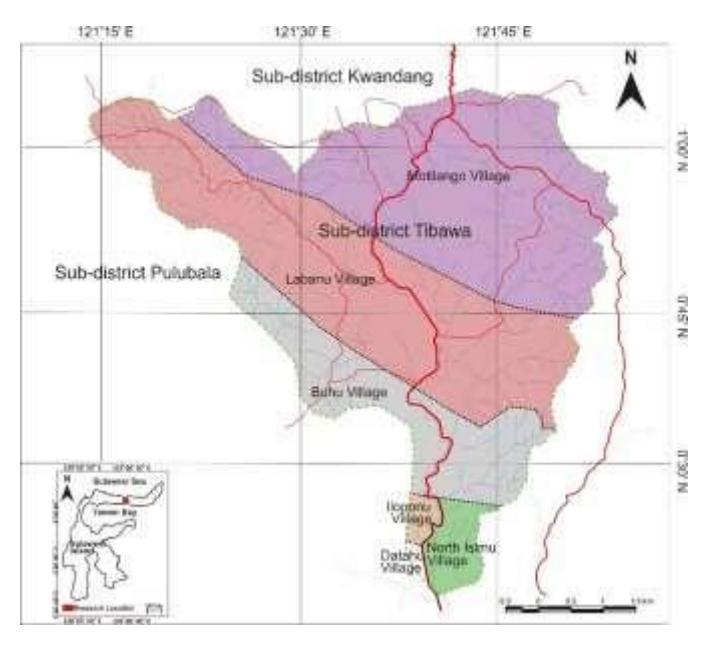
Figure 1. Map of Alo drainage basin

is a river with most sediment deposits of 124.83 tons/hectares flowing to Limboto Lake. Alo drainage basin covers six villages, namely Datahu, Iloponu, Buhu, Isimu Utara, Labanu, and Motilango village, all under the administration of Tibawa District. This is shown in Figure 1 as follows:

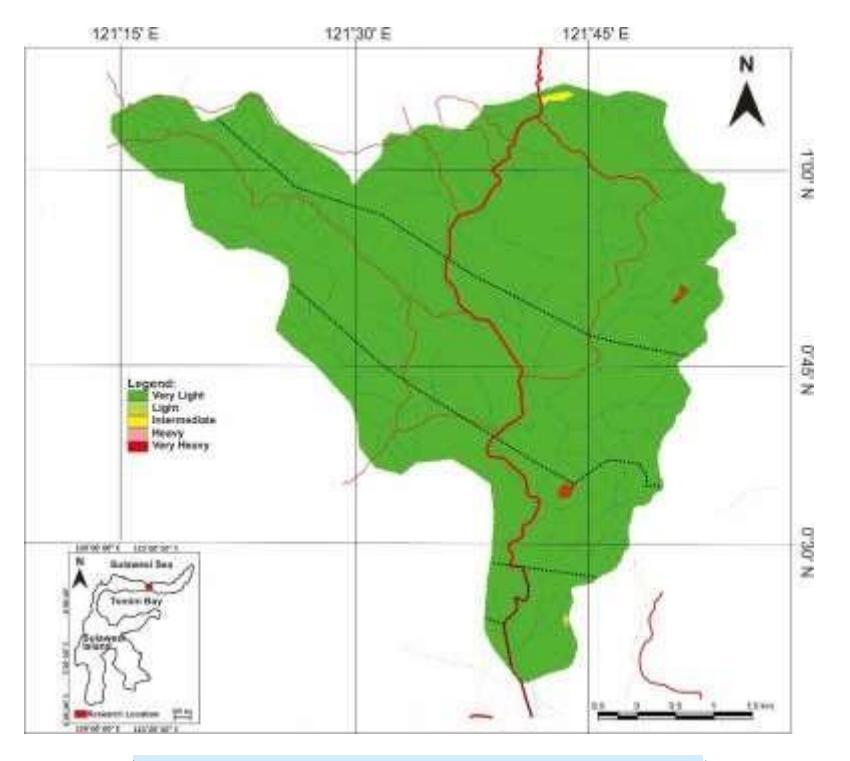
Figure 2. Map of soil surface erosion (A) of Alo watershed

Group III has 20 remaining land units, i.e., D2IB (0.140 ton/ha/year), D1IIIB (1.221 ton/ha/year), D1IIIPc (2.109 ton/ha/year), D1IIPc (0.069 ton/ha/year), D1IIPt (3.341 ton/ha/year), D2IPc (0.022 ton/ha/year), D2IPt (0.069 ton/ha/year), D1IVB (0.154 ton/ha/year), D1IVPc (0.640 ton/ha/year), D1IVPt (3.253 ton/ha/year), D2IB (0.140 ton/ha/year), D1IIIB (1.221 ton/ha/year), D1IIPc (2.109 ton/ha/year), D1IIPc (0.069 ton/ha/year), D1IVPc (0.154 ton/ha/year), D2IPc (0.022 ton/ha/year), D2IPt (0.069 ton/ha/year), D1IVP (0.154 ton/ha/year), D1IVPc (0.640 ton/ha/year), and D1IVPt (3.253 ton/ha/year). Erosion rate of these units is quite small attributable to area of each unit, ergo, the average of soil loss in Alo watershed is classified as small with the loss of 3,1 mm soil annually.

Additionally, all land units of karst hills have a value below 10 ton/hectare/year, those are: K2IB (0.720 ton/ha/year), K1IIIB (0.307 ton/ha/year), K1IIIPc (0.197 ton/ha/year), K2IPk (0.819 ton/ha/year), K2IPm (0.788 ton/ha/year), K1IVB (0.165 ton/ha/year), and K1IVPc (2.287 ton/ha/year). The erosion rate is low, owing to low rate of rain erosivity.

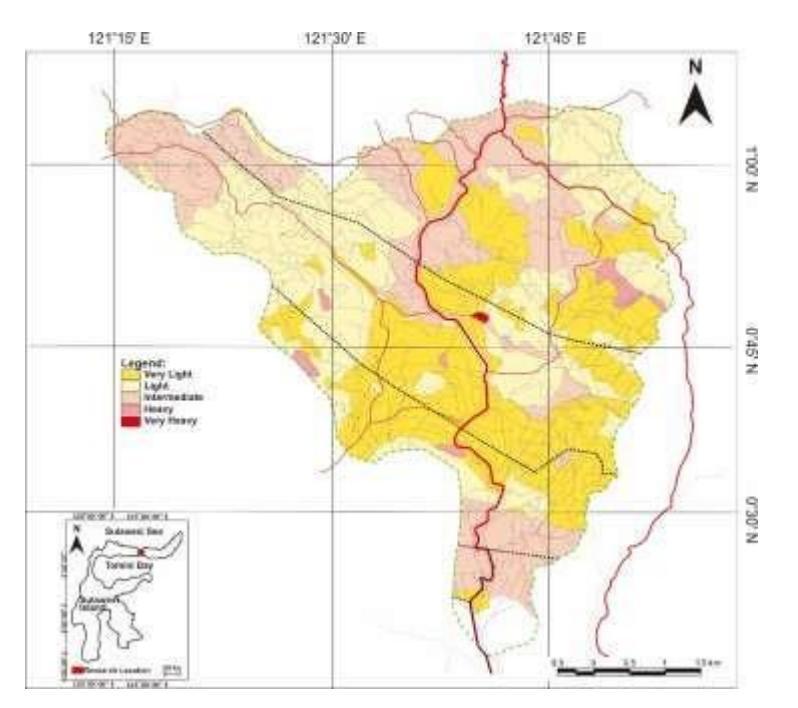
Figure 3. Map of Erosion Hazard Rate in Alo drainage basin

The table shows that four land units, D1IIIPt (89.599 ton/ha/year), D1VPc (15.657 ton/ha/year), S1IVB (67.652 ton/ha/year), and S1IVPt (102.608 ton/ha/year) are in the critical zone. These units are scoring high to extremely high EHR value. This results from the slope steepness and CP value as the key factors. In particular, land unit D1IVPt is in class IV steepness. However, its use as dry farmland makes it under bad caretaking and accordingly has CP value of 0,007. Besides, soil solum of the unit is shallow, only 35 cm, by that, the actual erosion exceeds tolerable erosion rate. Further, Figure 3 displays spread map of EHR in Alo drainage basin.

It shows that 98.75 percents of land units (a total of 6,874.21 hectares) in Alo watershed are in classified as extremely low to moderate. The remaining 1.25 percents are in high – extremely high rate. The maximum erosion hazard rate of Alo basin takes place in some land units. The units involved are D1IVPc (16.88 hectares) in Buhu Village, unit D1IVPc (7.71 hectares) in Labanu Village, two units; S1IVPc and S1IVB in Motilango Village (having area of 6.83 and 47.11 hectares respectively), and one unit in downstream of Alo basin, S1IVPt, with an area of 5.4 hectares. In total, land units categorized in extremely low hazard rate have accumulated area of 2.200,53 ha, those in the low category have a total of 2,776.64 ha, unit in the moderate class have 1,896.99 hectares, units in high and extremely high have a total area of 93.86 and 5.50 hectares in order. The analysis of erosion hazard spread points out that inappropriate land use in Alo watershed has brought the land capacity to the limit, if not taken care of, it will eventually increase the hazard rate.

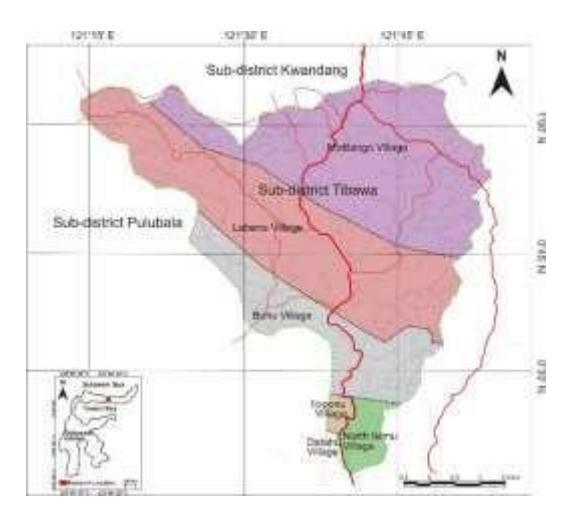
Figure 1. Map of Alo drainage basin

The research took place in Alo drainage basin, Tibawa District, Gorontalo Regency, Gorontalo Province, precisely at the west of Limboto District. Tibawa District is at the longitude of $122^{\circ}46'56'' - 122^{\circ}53'47''E$ and latitude of $00^{\circ}45'51'' - 00^{\circ}39'14''N$. Alo river is a river with most sediment deposits of 124.83 tons/hectares flowing to Limboto Lake. Alo drainage basin covers six villages, namely Datahu, Iloponu, Buhu, Isimu Utara, Labanu, and Motilango village, all under the administration of Tibawa District. This is shown in Figure 1 as follows:

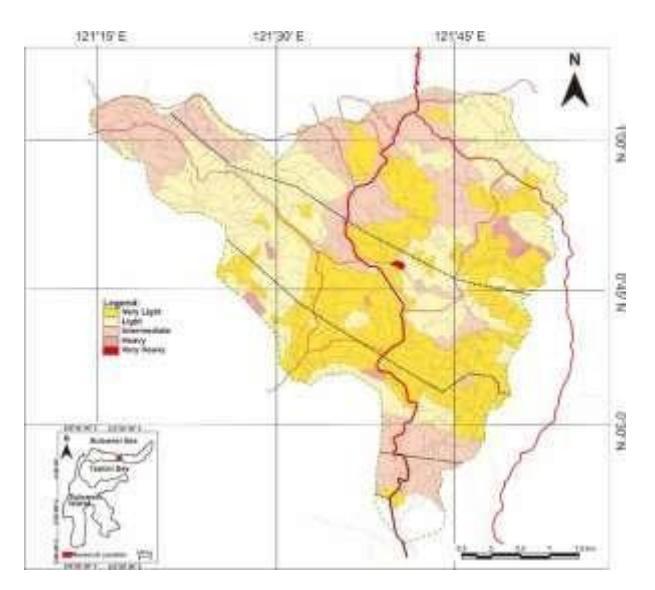
Figure 2. Map of Erosion Hazard Rate in Alo drainage basin

The parameters can help when determining five levels of erosion hazard; extremely low, low, moderate, high, and extremely high. The result is shown in Table 2. The table shows that four land units, D1IIIPt (89.599 ton/ha/year), D1VPc (15.657 ton/ha/year), S1IVB (67.652 ton/ha/year), and S1IVPt (102.608 ton/ha/year) are in the critical zone. These units are scoring high to extremely high EHR value. This results from the slope steepness and CP value as the key factors. In particular, land unit D1IVPt is in class IV steepness. However, its use as dry farmland makes it under bad caretaking and accordingly has CP value of 0.007. Besides, soil solum of the unit is shallow, only 35 cm, by that, the actual erosion exceeds tolerable erosion rate. Further, Figure 2 displays spread map of EHR in Alo drainage basin.

It shows that 98.75 percents of land units (a total of 6,874.21 hectares) in Alo watershed are in classified as extremely low to moderate. The remaining 1.25 percents are in high – extremely high rate. The maximum erosion hazard rate of Alo basin takes place in some land units. In total, land units categorized in extremely low hazard rate have accumulated area of 2.200.53 ha, those in the low category have a total of 2,776.64 ha, unit in the moderate class have 1,896.99 hectares, units in high and extremely high have a total area of 93.86 and 5.50 hectares in order. The analysis of erosion hazard spread points out that inappropriate land use in Alo watershed has brought the land capacity to the limit, if not taken care of, it will eventually increase the hazard rate.

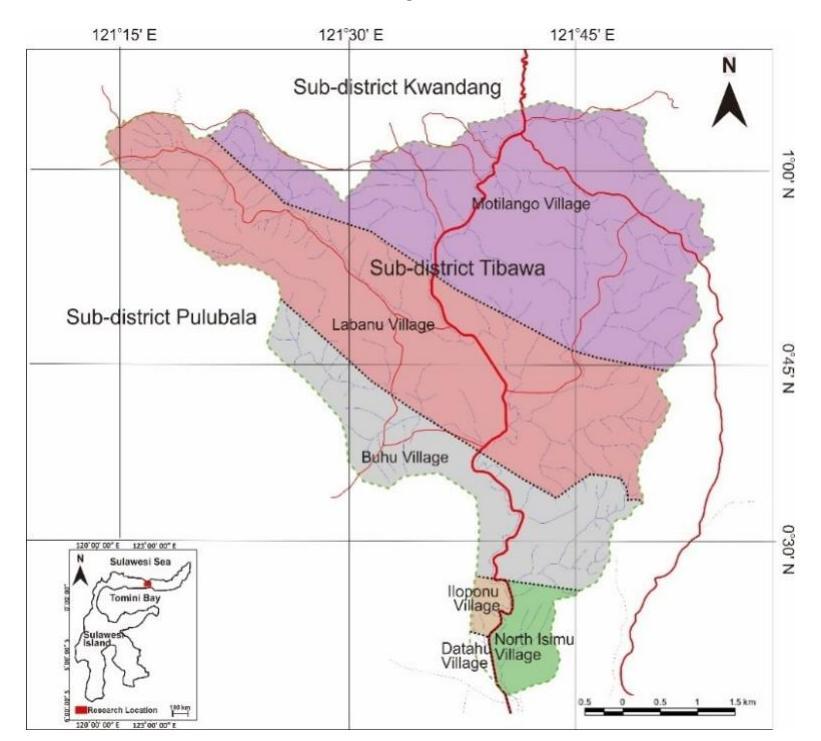
Figure 1 - Map of Alo drainage basin

Research Method. The research took place in Alo drainage basin, Tibawa District, Gorontalo Regency, Gorontalo Province, precisely at the west of Limboto District. Tibawa District is at the longitude of $122^{\circ}46'56'' - 122^{\circ}53'47''E$ and latitude of $00^{\circ}45'51'' - 00^{\circ}39'14''N$. Alo river is a river with most sediment deposits of 124.83 tons/hectares flowing to Limboto Lake. Alo drainage basin covers six villages, namely Datahu, Iloponu, Buhu, Isimu Utara, Labanu, and Motilango village, all under the administration of Tibawa District. This is shown in figure 1 as follows:

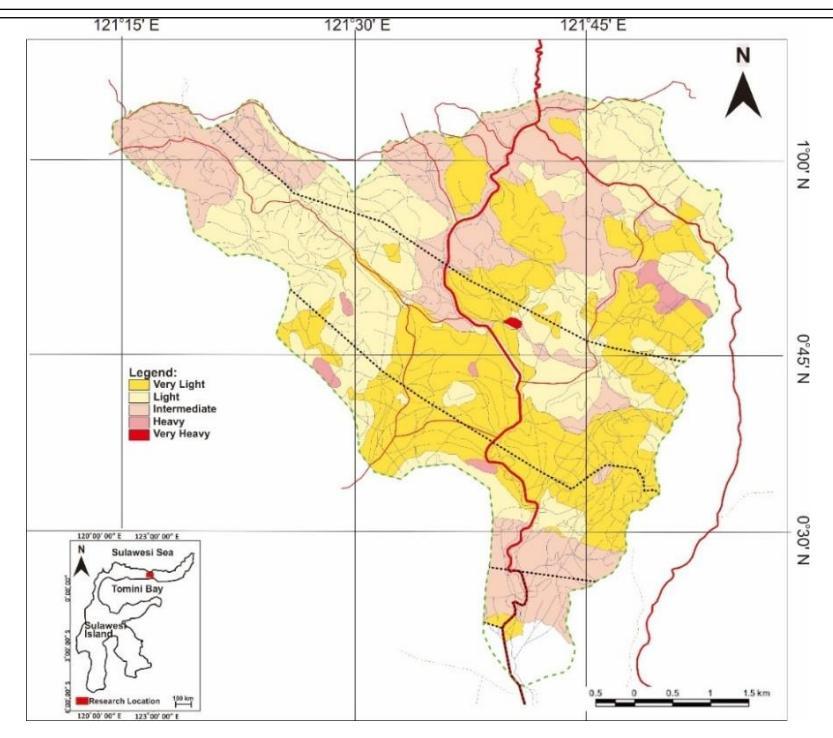
Figure 2 – Map of Erosion Hazard Rate in Alo drainage basin

It shows that 98.75 percents of land units (a total of 6,874.21 hectares) in Alo watershed are in classified as extremely low to moderate. The remaining 1.25 percents are in high – extremely high rate. The maximum erosion hazard rate of Alo basin takes place in some land units. In total, land units categorized in extremely low hazard rate have accumulated area of 2.200.53 ha, those in the low category have a total of 2,776.64 ha, unit in the moderate class have 1,896.99 hectares, units in high and extremely high have a total area of 93.86 and 5.50 hectares in order. The analysis of erosion hazard spread points out that inappropriate land use in Alo watershed has brought the land capacity to the limit, if not taken care of, it will eventually increase the hazard rate.
