Evaluation of the Living Condition in Fishermen Settlement in the Coastal Area of Marisa City, Gorontalo Province

2 Evaluation of the Living Condition in Fishermen Settlement in the Coastal Area of Marisa City, Gorontalo Province

Irwan Wunarlani^{1,2}, Sugiono Soetomo¹, Iwan Rudiarto³

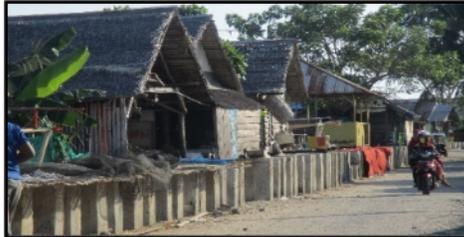
Figure 5: Permanent house of fisherman in Pohuwato and Pohuwato Timur (Source: Authors, 2018)

The settlement is regarded as a high-density area, thus leaving the impression that the settlement resembles a slum area with bad sanitation. Most of the houses are made of wood and bamboo, although there are some concrete houses with gable roofs. Furthermore, the materials of the roof of the houses in the area are zinc and thatch. Each house has a mooring. Currently, the two villages have no fishing ports that function as a port or harbor for landing and distributing fish.

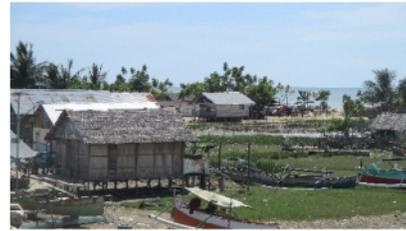
Figure 7: Simple fishermen's settlement in Pohuwato Village and Pohuwato Timur Village (Source: Authors, 2018)
