IOP Conf. Series: Earth and Environmental Science 256 (2019) 012045

## Characteristic of water quality in upstream of Bolango River basin in Gorontalo Province

Abstract. This study aims to find out the characteristics of water quality in the upstream of Bolango River Basin so that it can be utilized by Gorontalo people. The study took place in the upstream of Bolango River Basin of Gorontalo Province. River water samples were taken at five points, namely upstream of Bolango River, Bolango at Bunuo Village, upstream of Mongiilo River, middle part of Mongiilo River and estuary of Mongiilo River. Groundwater samples were taken from one location as a control, namely Kopi Village, in Bone Bolango Regency, Gorontalo Province. Water quality was analyzed at the Research Center and Industry Standardization Laboratory of Manado. The examined parameters of consisted of physical, chemical and biological aspects. Criteria for the characteristics of river water quality referred to the Government Regulation Number 82 of 2001 Class II and Water Pollution Index referred to the Decision of Minister of Environment Number 115 of 2003. Groundwater quality referred to the Regulation of Minister of Hea

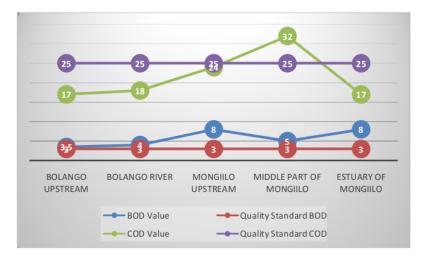
Figure 2. Results of BOD and COD Parameter Analysis.

Organic materials can take the form of carbohydrates, oils, fats and waxes, proteins, amino acids, detergents, soaps and pesticides. BOD only describes organic material that can be decomposed biologically (biodegradable). Organic materials are the result of decay of relatively dead plants and animals or the result of waste from domestic and industrial waste. The BOD value of waters is affected by temperature, plankton density, presence of microbes, and types and concentration of organic materials [1]. The contamination of organic materials can be indicated by the high parameters of BOD and COD as shown in Figure 2.

The results of the COD analysis show the total amount of oxygen required to chemically oxidize organic materials, both which can be degraded biologically and which are difficult to be degraded

biologically. The existence of organic material can come from nature or from household and industrial activities. The COD values in unpolluted waters are usually less than 20 mg/l [1].
