THE ANALYSIS OF SLIDING SURFACE IN ALO WATERSHED, GORONTALO DISTRICT, INDONESIA

Abstract. Allo watershed is the sub-watershed within the system of Limboto watershed which directly disembogues to Limboto Lake. Land degradation happened in the Alo watershed is caused by the agricultural system that does not apply land conservation techniques such as terracing and mounds and it triggers erosion and landslide. The method used in this research is geoelectric method with Wenner Alpha configuration; while the data analysis utilizes resistivity imaging method which produces two-dimensional cross-sectional images. In total, there are seven trajectories with a length of 170-180 meters each. The result of the research presents the slip surfaces of 7 locations are located in 3-17 meters depth with the inclination of 11° -79° trending dominantly northwest and one location trending southeast.

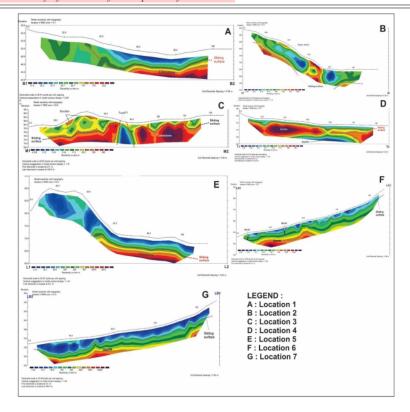
Figure 2. Cross section of 2D resistivity imaging at 7 lines at the research location

Result and Discussion. The measurement result of the resistivity value and rock type at the research location are shown in Table 1. The data in Table 1 shows that the rock types at 7 locations consist of clay, gravel, sand, limestone and dacite. Geoelectric measurement in research area refers to the inversion result of 2D resistivity imaging on the lines in seven location shown in Figure 2.

Location 1: Geoelectric measurements at location 1 are in North Isimu Village, 180 meters long, with a southwest-northeast trend. The slip plane is usually characterized by a contrasting field between high and low resistance values. Based on the rock resistance value, the slip plane at location 1 is estimated to be in the limestone layer as a layer with a high resistance value. The upper layers of the slip plane with resistance values of less than 674 Ωm were detected or suspected to be clay, gravel and sand layers. The limestone layer, which is a boundary plane or a slip plane, is detected at a depth of about 5-7 meters and has a high resistance of between $674-10,950.5\Omega m$ with an apparent slope of about 8° to the southwest. On the basis of the apparent slope, the actual slope is 47° to the northwest.

Location 2: Geoelectric measurement at location 2 is at North Isimu Village, 180 meters long, with a south-north trend. Based on the rock resistance value, the slip plane at location 2 contains layers of clay, gravel, sand, limestone and dacite. The slip plane at location 2 is estimated to be in the plane of contrast between low and high resistance values. The upper layers of the slip plane with resistance values of less than $692\Omega m$ are thought to be rock layers, i.e. clay, gravel and sand layers. The limestone layer, which is a slip plane, was detected at a depth of about 3 meters and has a high resistance of 692-9,479 Ωm with an apparent slope of about 11° southwest. Based on the apparent slope, the actual slope to the northwest is 79° .

Location 3: Geo-electric measurement at location 3 North Isimu Village with a length of 170 meters trending southwest – northeast. Based on the rock resistance value, the slip plane at location 3 is estimated to be in the contrasting plane between low and high resistance values, i.e. in the limestone layer. A layer of clay, gravel, and sand is thought to be the upper layer of the slip plane, which has a resistance value of less than 796 Ω m.The limestone layer, which is a slip plane, is detected at a depth of about 5-8 meters and has a high resistance of 796-10,552.5 Ω m with an apparent slope of about 7° to the southwest Based on the apparent slope, the actual slope is 74° to the northwest.

Location 4: Geo-electric measurement at location 4 in North Isimu Village with a track length of 180 meters trending northeast - southwest. The limestone layer which is a slip plane is detected at a depth of about 4-5 meters which has a high resistivity ranging from 586-14,113-m with an apparent slope of about 3° to the southwest. Based on the apparent slope, the actual slope is 56° trending the northwest.

Location 5: Geo-electric measurement at location 5 in North Isimu Village with a track length of 180 meters trendingsoutheast - northwest. The slip area is estimated to have low and high resistance values, namely in the dacite layer. The upper layers of the slip plane with resistance values of less than 20,188 -m are thought to be layers of clay, gravel, sand and dry gravel. The igneous rock layer of the dacite, which is a slip plane, was detected at a depth of about 17 meters, which has a high resistance of >20,188 -m, with a true dip of about 11° to the southeast.

Location 6: Geo-electric measurement at location6 in Labanu Village with a track length of 180 meters trendingeast - west. The slip area is estimated in low and high resistance values, namely in the dacite layer. The upper layers of the slip plane with resistance values of less than $536\Omega m$ are thought to be layers of clay, loamy sand, gravel and sand. The limestone layer, which is a slip plane, was detected at a depth of about 2 meters, which has a

resistance of $> 536\Omega m$, with a true dip of about 13° to the east

Location 7: Geo-electric measurement at location 7 in Labanu Village with a track length of 180 meters trending east - west. The slip area is estimated in low and high resistance values, namely in the dacite layer. The upper layers of the slip plane with resistance values of less than 692 Ω m are thought to be layers of clay, gravel and sand. The limestone layer, which is a slip plane, was detected at a depth of about 2-5 meters, which has a resistivity of > 692 Ω m, with a true dip of about 11° to the east.

Conclusion. Based on the results of the interpretation and analysis, it can be concluded that the two-dimensional cross-section of the track at locations 1, 2, 3, 4 and 7 is thought to be the structure of the subsurface soil in the form of clay, gravel and sand. The line at location 5 has a subsurface layer of dry gravel under the sand. The track at location 6 has a sub-surface layer of loamy sand under the layer of clay. The slip plane is interpreted as a limestone layer in line 5 is assumed to be in a dacite igneous rock layer. The results showed that the landslide slip fields at 7 locations were approximately 3-17 meters deep with a slope angle of 110 -79° with trending dominantly northwest and one location with a southeast trend.
